## Selection of Buildings for FRP Retrofitting

Li Bing

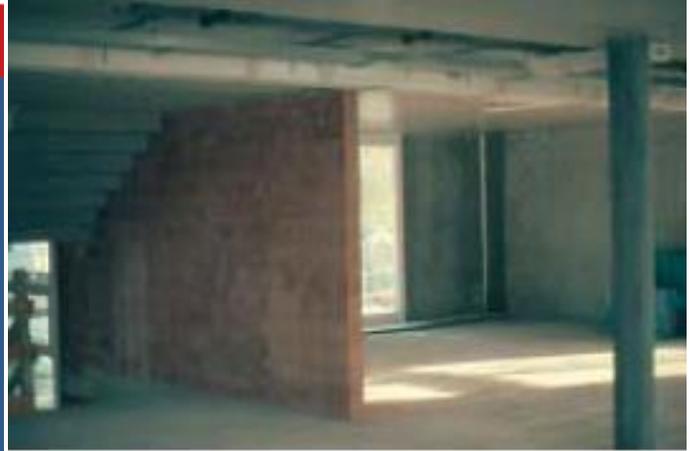
Avoid «bracing» of frames with masonry infills!

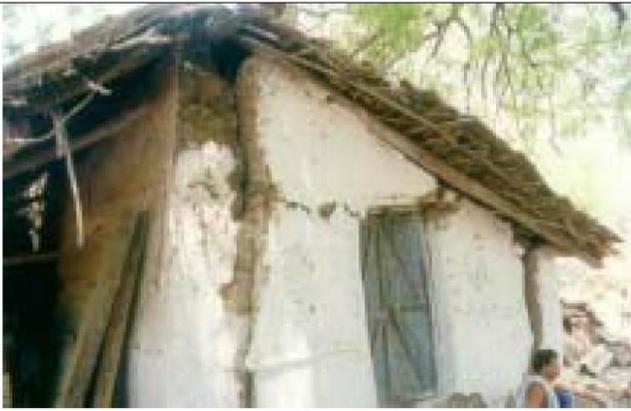
Cracking and separation of adobe walls – 1997 Jabalpur, India earthquake (Report #23)

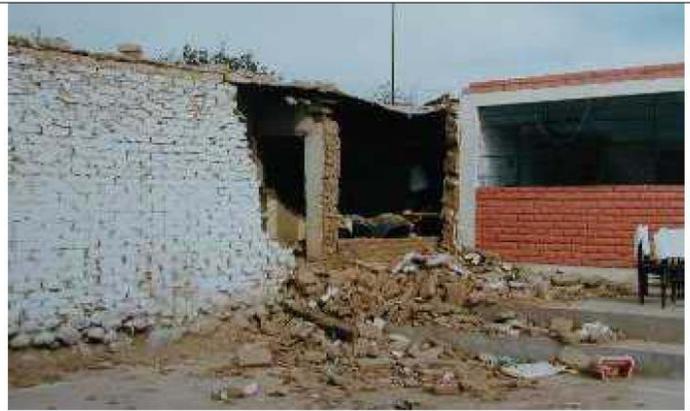
Out-of-plane wall collapse – 1996 Nazca earthquake, Peru (Report #52)

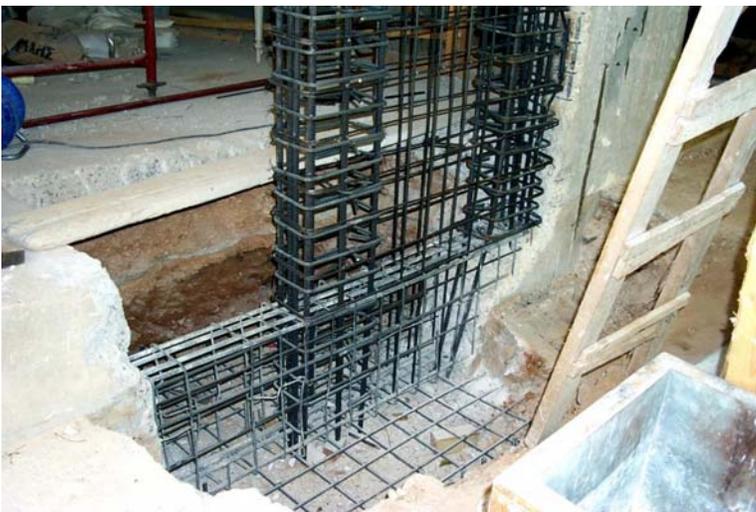
Photo 15. Installing the main steel.
